Range Environmental Vulnerability Assessment  
5-Year Review  
Marine Corps Logistics Base Barstow  
May 2013

# **Range Environmental Vulnerability Assessment**

## **5-Year Review**

### **Marine Corps Logistics Base Barstow Barstow, California**

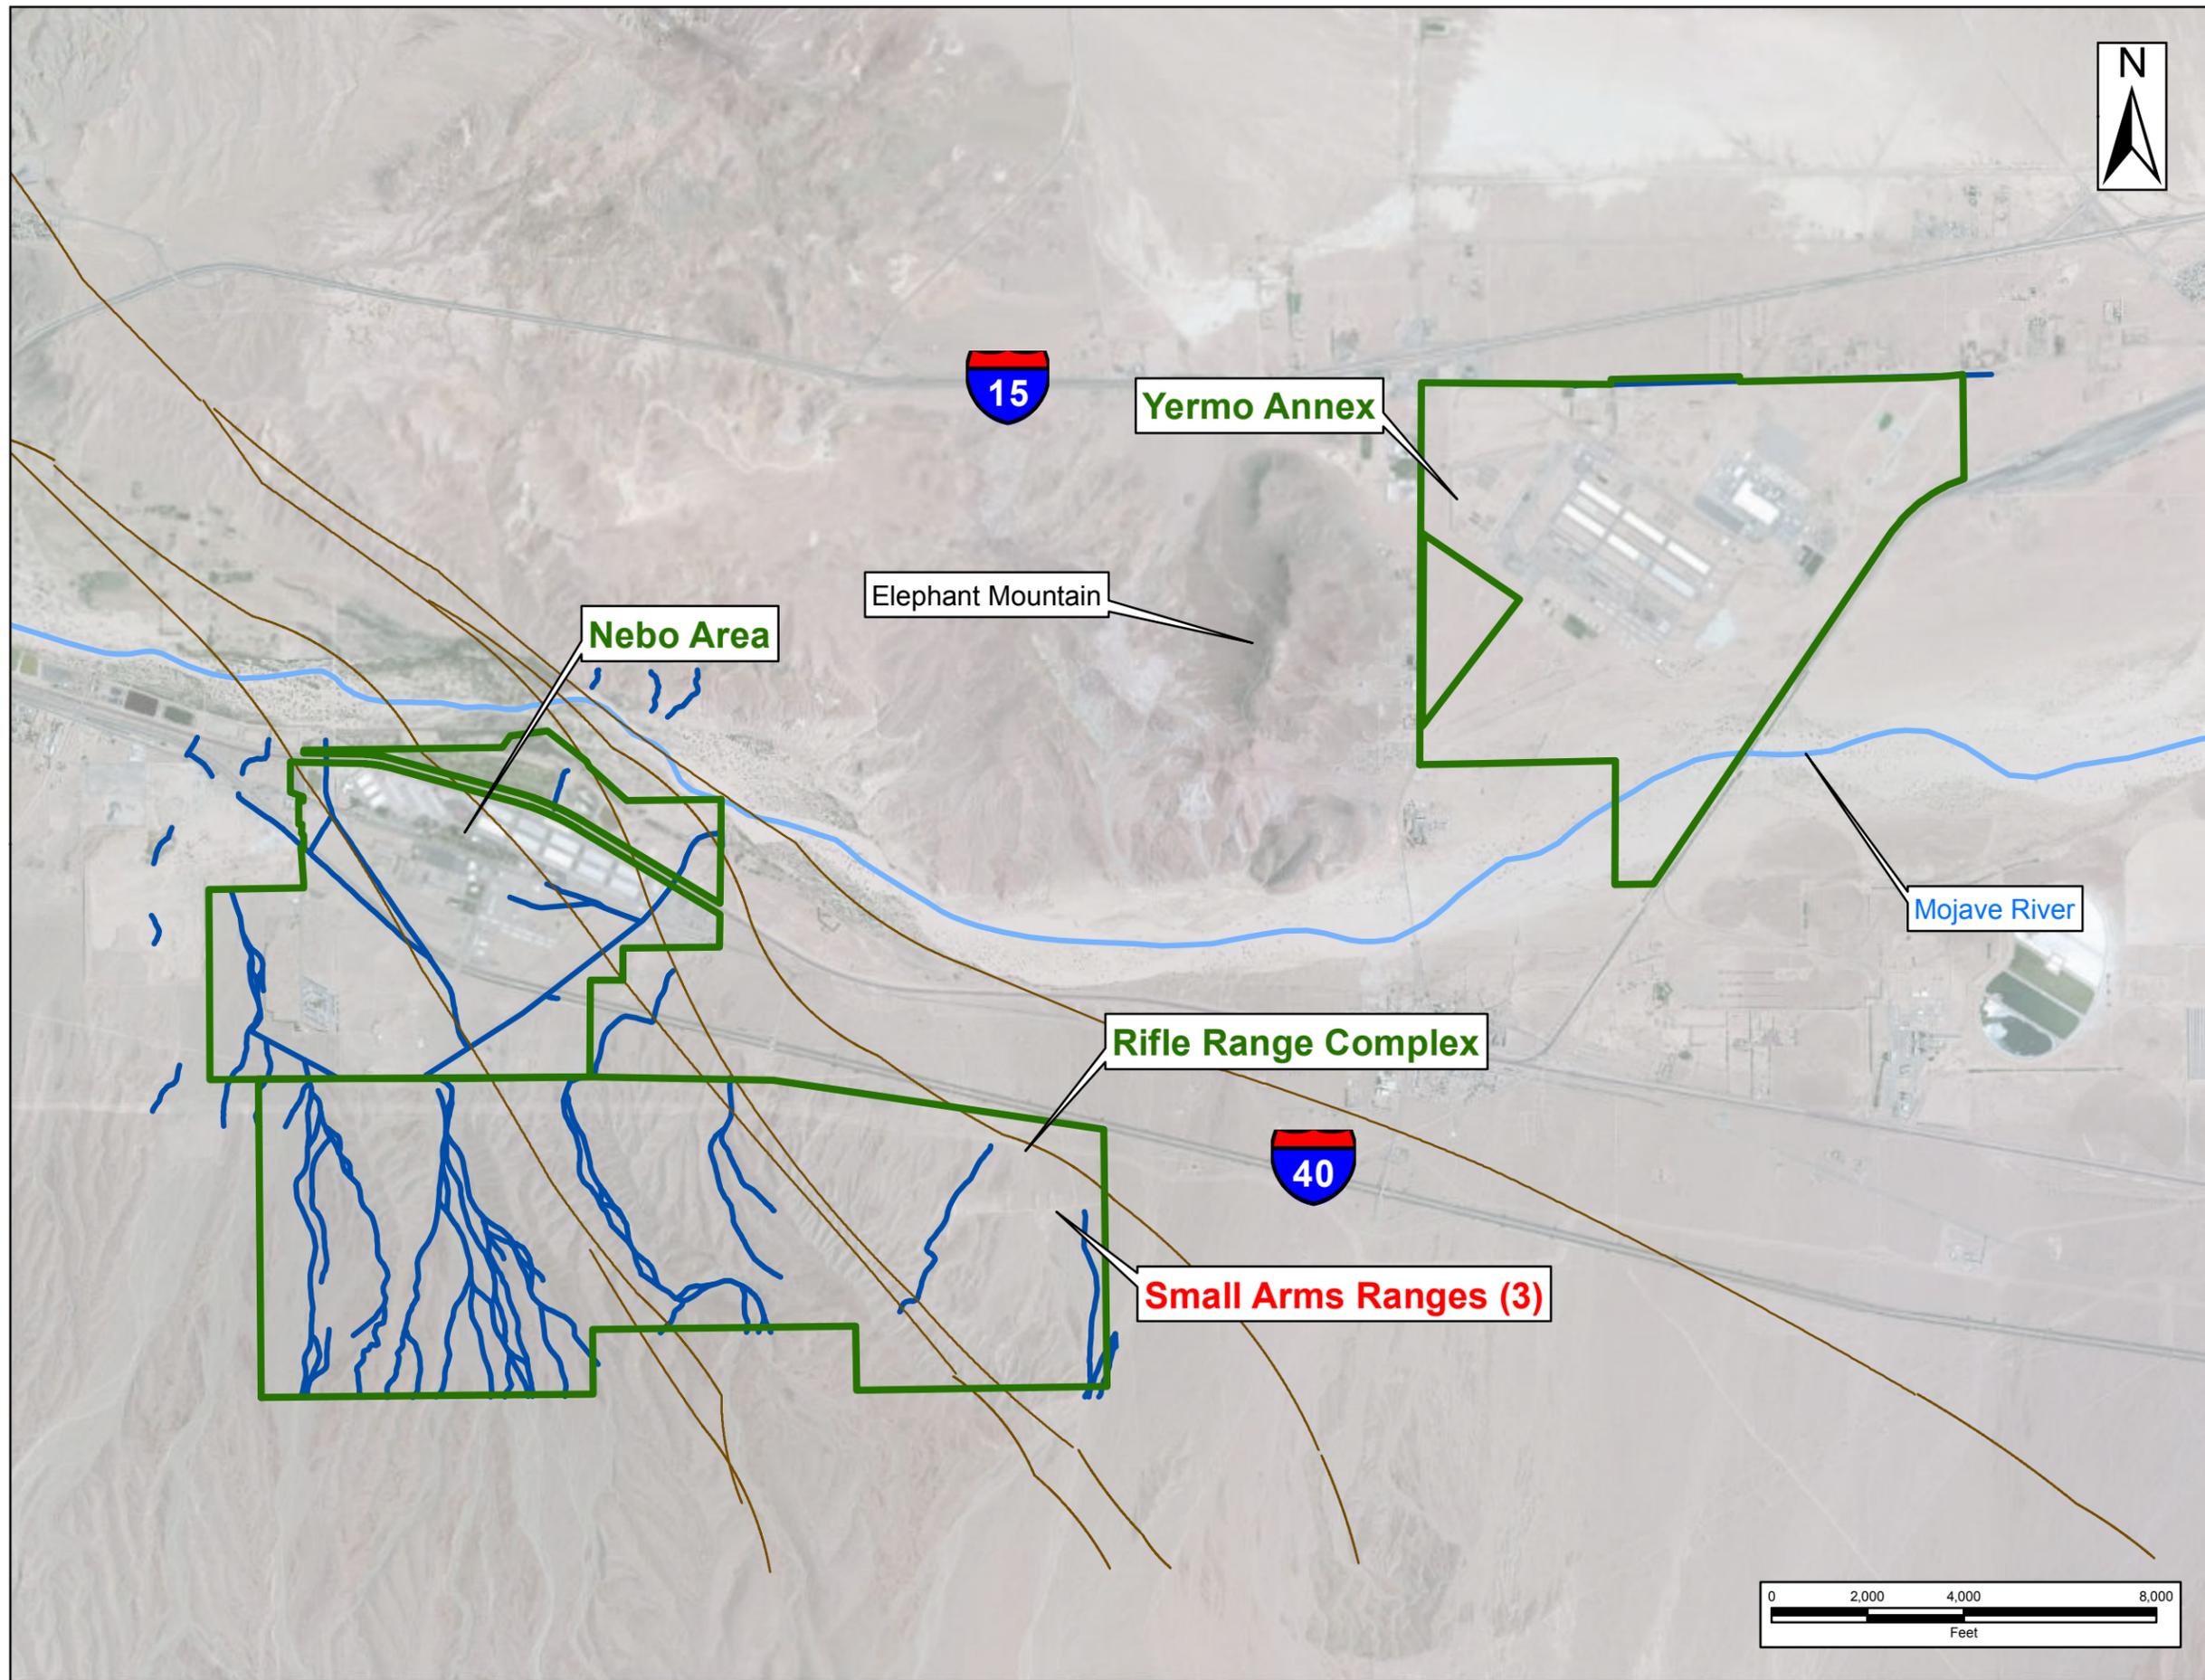
**FIGURE 1-2  
Installation Map**

MCLB Barstow is located in San Bernardino County in south-central California, approximately 3.5 miles east of the city of Barstow, CA (**Figure 1-1**). Its primary mission is to procure, maintain, store, and issue supplies and equipment for Marine Corps facilities worldwide, as well as to repair and rebuild DoD equipment. MCLB Barstow comprises approximately 5,405 acres. The installation is divided into three areas: the Nebo Area (1,286 acres), the Yermo Annex (1,681 acres), and the Rifle Range Complex (2,438 acres) (**Figure 1-2**) (Tierra Data, 2011).

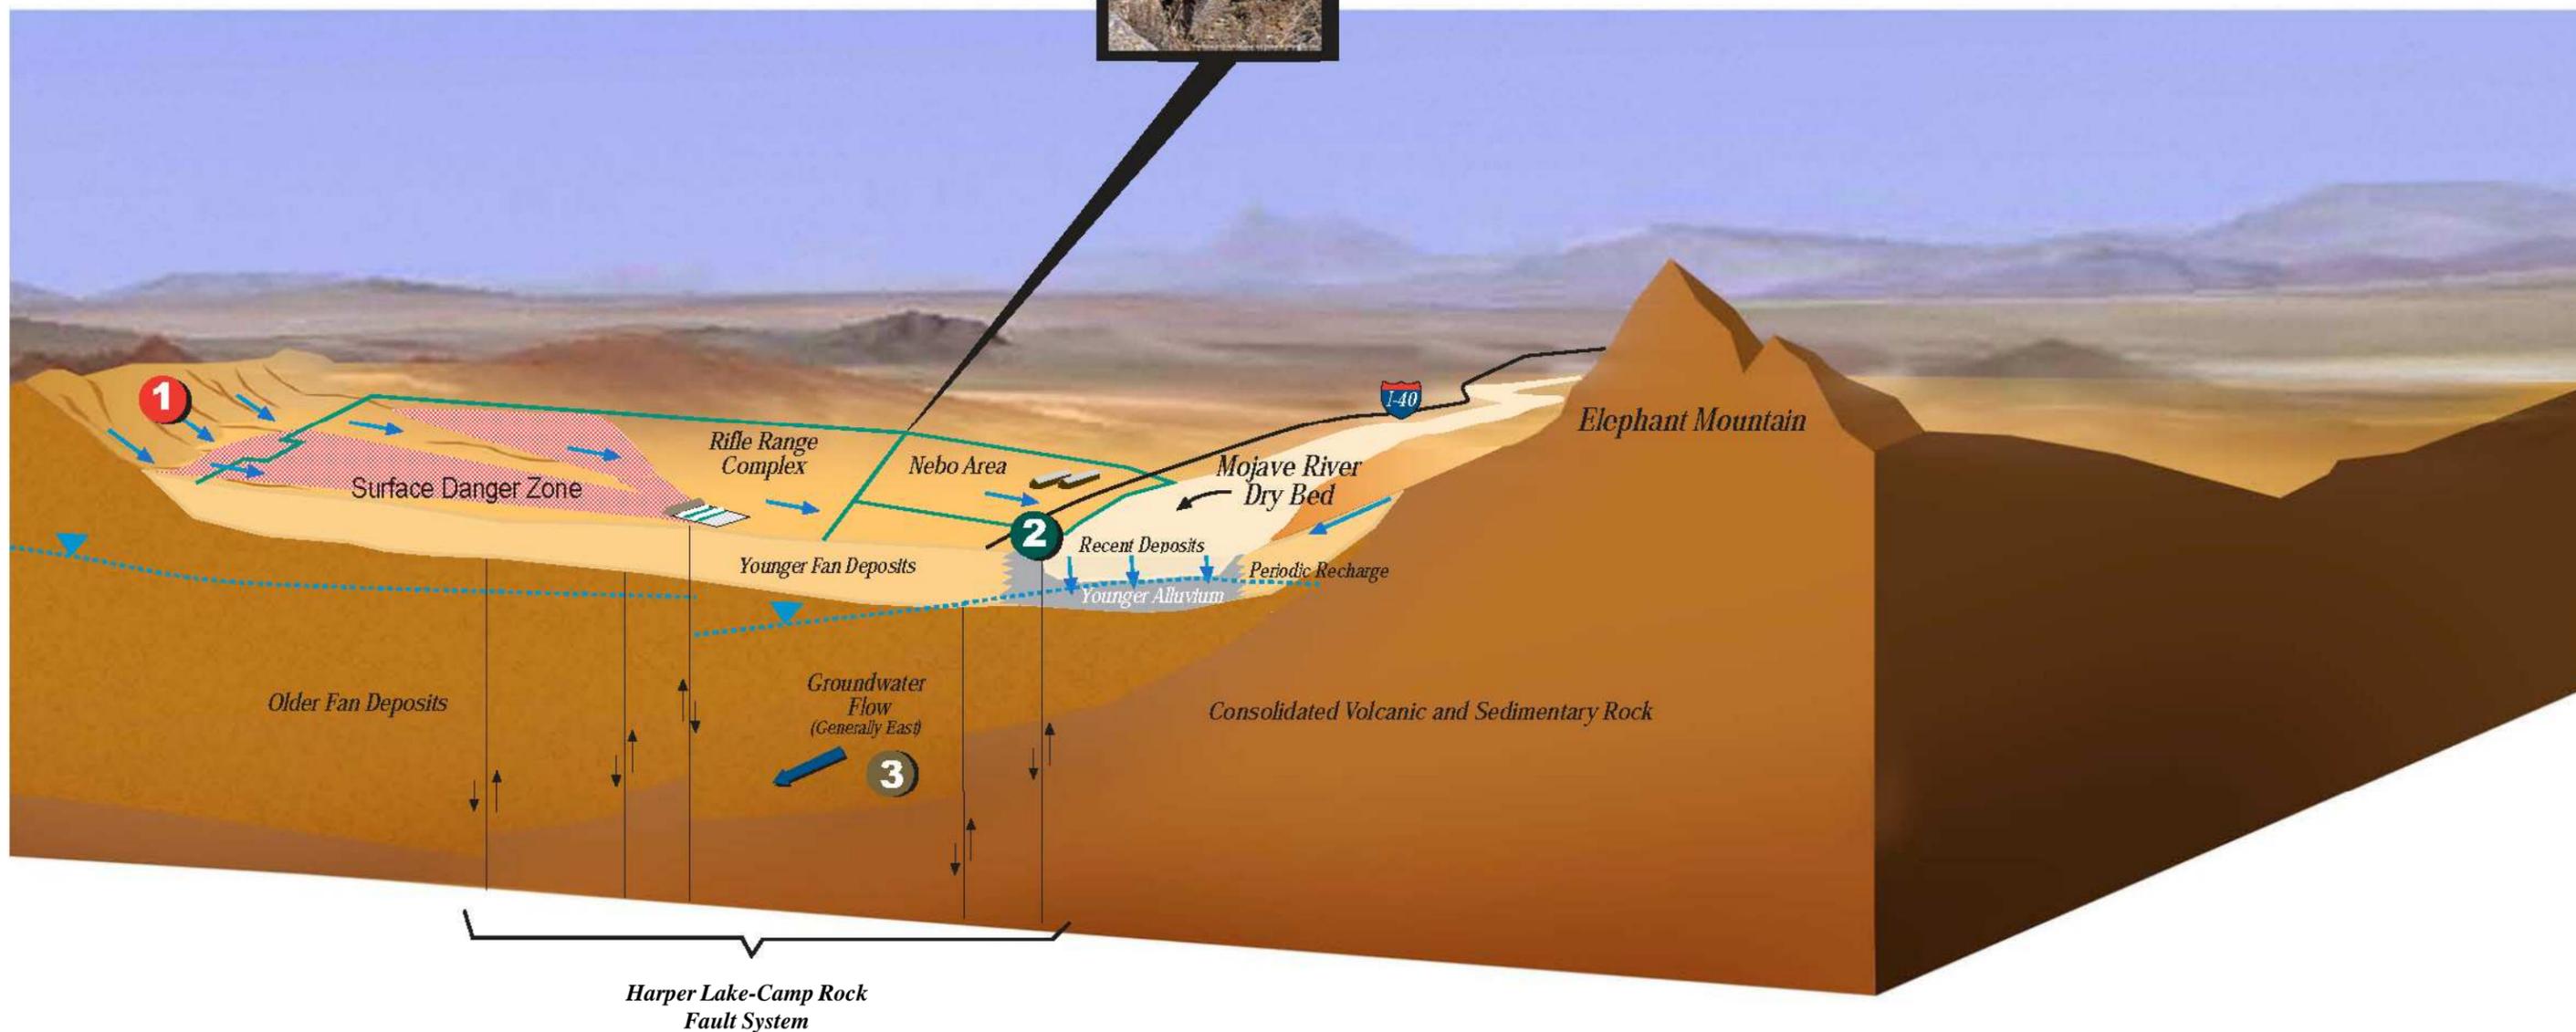
A schematic diagram depicting the site conditions addressed in the CSM is presented in **Figure 4-1**. This figure shows the topography and geologic structures of the installation relative to the operational ranges, the range boundary, and surface water and groundwater pathways.

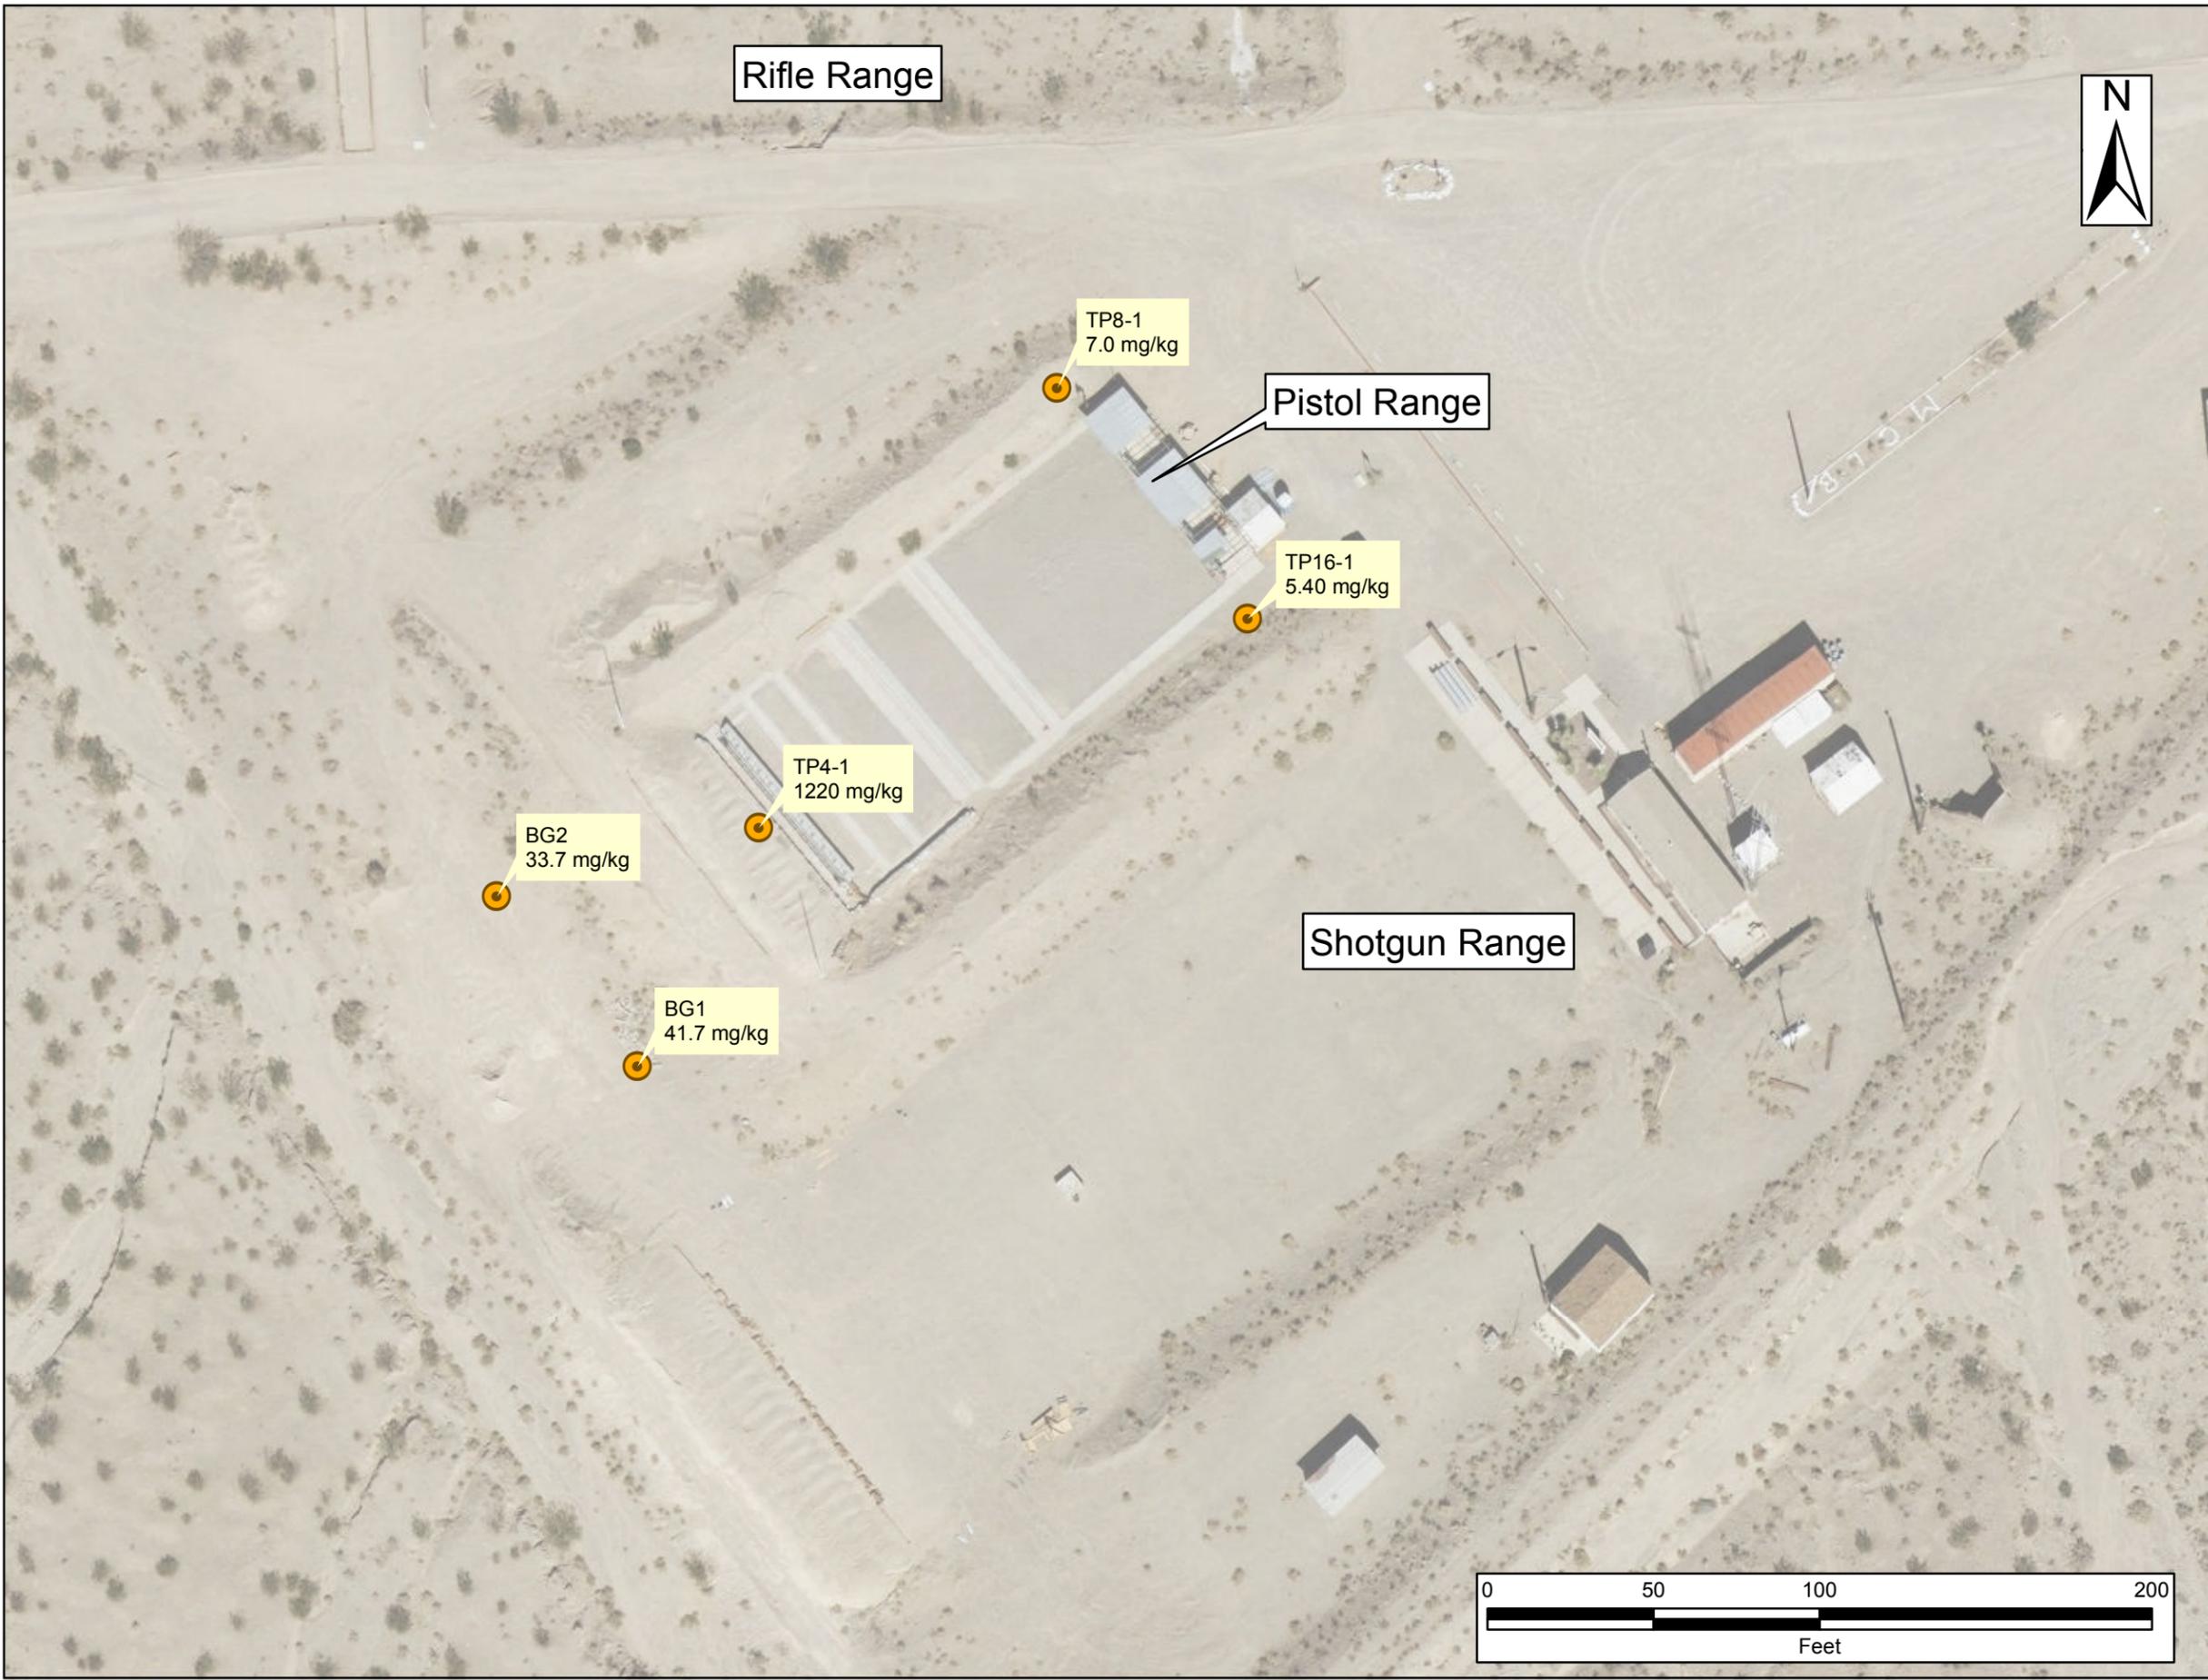
**Figure 5-2**  
**Pistol and Shotgun Ranges**  
 Range Environmental  
 Vulnerability Assessment  
 5-Year Review  
 MCLB Barstow  
 Barstow, CA

Soil Sample ID  
Lead Concentration (mg/kg)

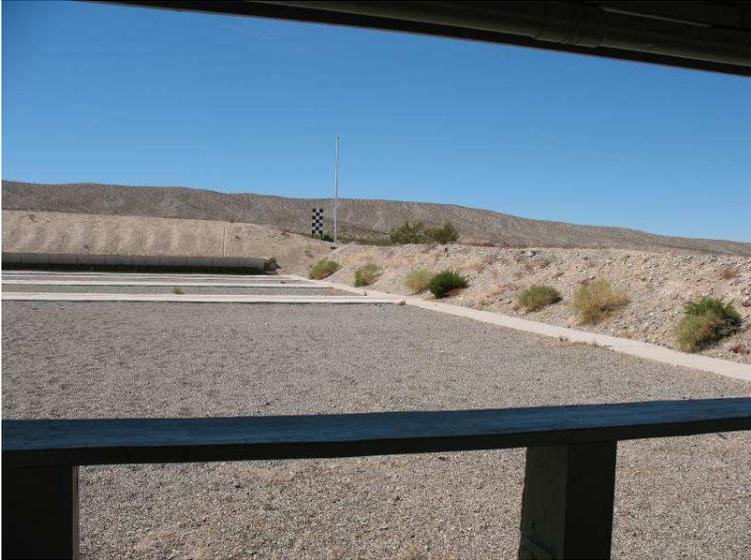
<b>Photographic Log</b>	
<b>Project:</b> MCLB Barstow		<b>Location:</b> Barstow, California	
		<b>Project No.</b> 06285037.0000	
<b>Photo No.</b> 1	<b>Date:</b> 3-22-2012

<b>Description:</b> Pistol Range; View downrange during March 2012 site visit.

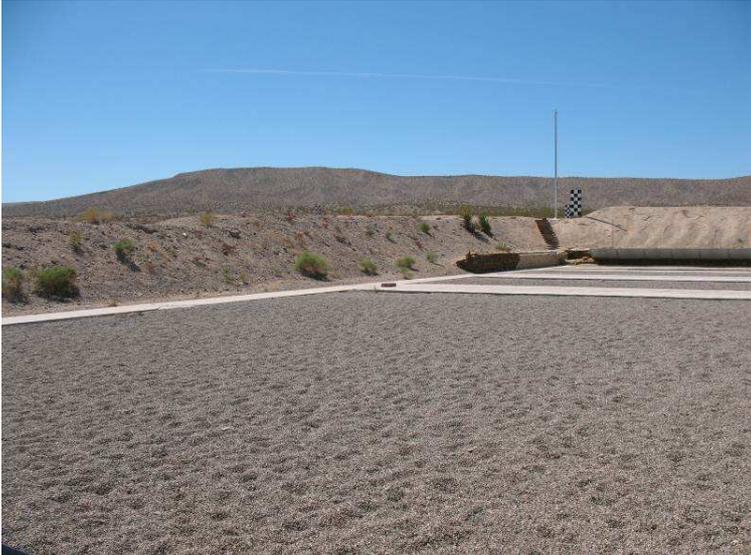
<b>Photographic Log</b>	
<b>Project:</b> MCLB Barstow		<b>Location:</b> Barstow, California	
		<b>Project No.</b> 06285037.0000	
<b>Photo No.</b> 2	<b>Date:</b> 3-22-2012

<b>Description:</b> Pistol Range; View downrange during March 2012 site visit.

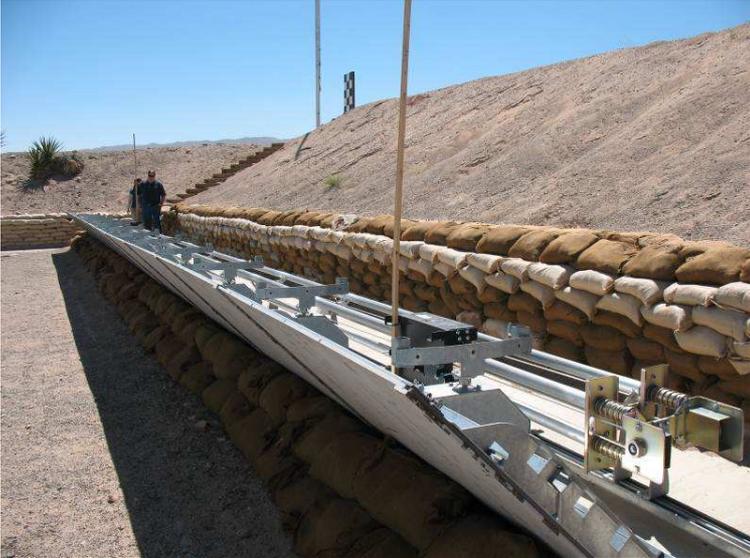
<b>Project:</b> MCLB Barstow		<b>Location:</b> Barstow, California	<b>Project No.</b> 06285037.0000
<b>Photo No.</b> 4	<b>Date:</b> 3-22-2012

<b>Description:</b> Pistol Range: target carriages and berm during March 2012 site visit.

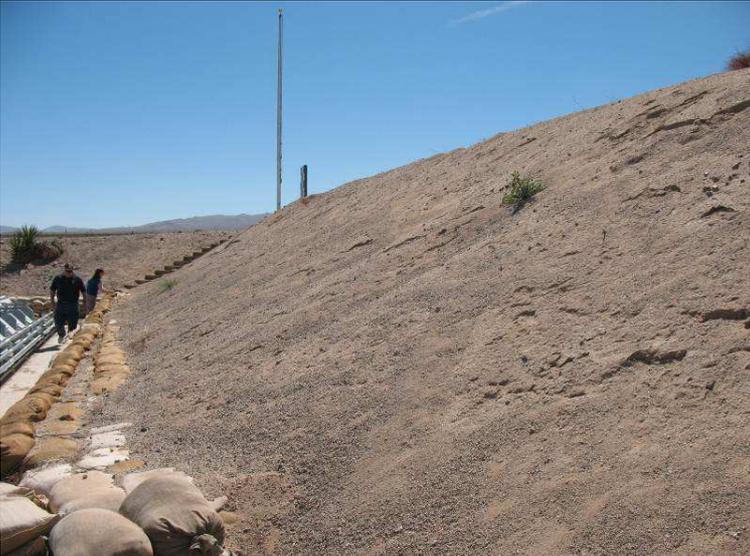
<b>Project:</b> MCLB Barstow		<b>Location:</b> Barstow, California	<b>Project No.</b> 06285037.0000
<b>Photo No.</b> 5	<b>Date:</b> 3-22-2012

<b>Description:</b> Pistol Range: berm face during March 2012 site visit.

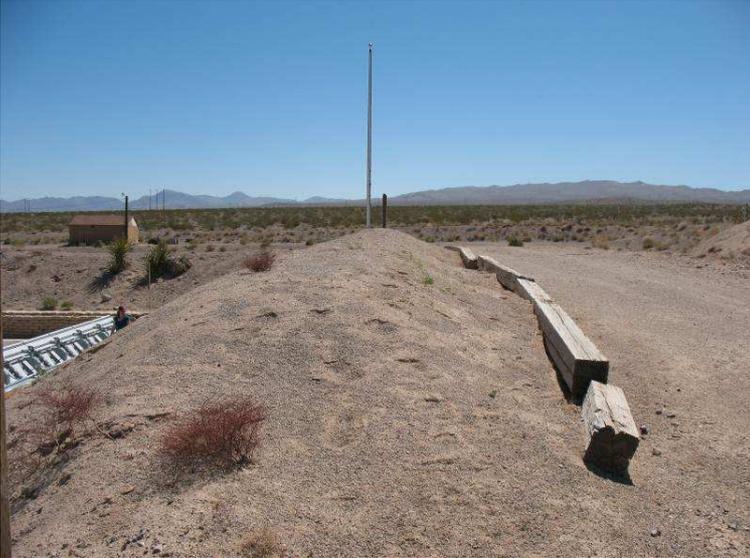
<b>Project:</b> MCLB Barstow		<b>Location:</b> Barstow, California	<b>Project No.</b> 06285037.0000
<b>Photo No.</b> 6	<b>Date:</b> 3-22-2012

<b>Description:</b> Pistol Range: Top of berm, note slope away from the face of the berm, and flat terrace. March 2012 site visit.

<b>Engineered controls</b>	<p>Sandbags are placed across the top of the Rifle Range berm to help prevent erosion caused by high-energy runoff. The tops of all the berms are sloped slightly away from the berm face to minimize drainage flow across the impact area. Sandbags or wooden beams are present at the foot of the berms at the Pistol and Shotgun Ranges to help capture any erosion down the face of the berms. In addition, during berm reconstruction in August 2012 erosion control matting was installed on the face of the berms at all three ranges to limit soil erosion on the berm faces. The back sides of the Pistol and Shotgun ranges are terraced down to a flat road bed. Side berms at the Pistol and Shotgun Ranges divert</p>

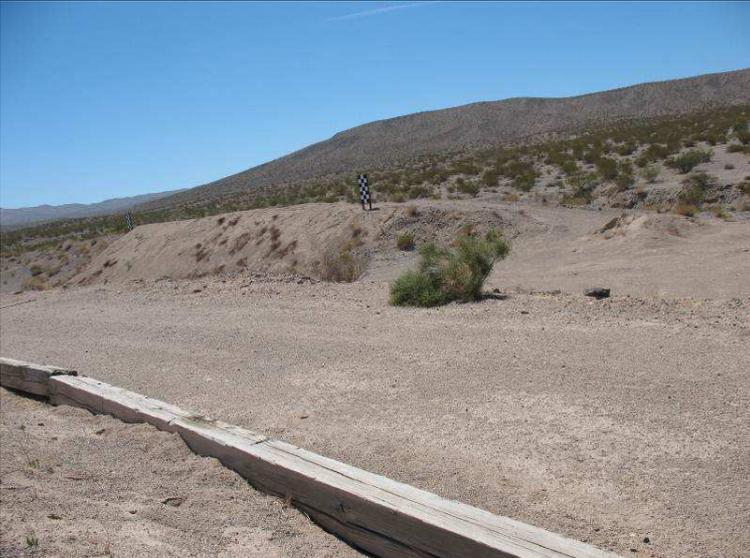
<b>Project:</b> MCLB Barstow		<b>Location:</b> Barstow, California	<b>Project No.</b> 06285037.0000
<b>Photo No.</b> 7	<b>Date:</b> 3-22-2012

<b>Description:</b> Pistol Range, behind berm during March 2012 site visit.

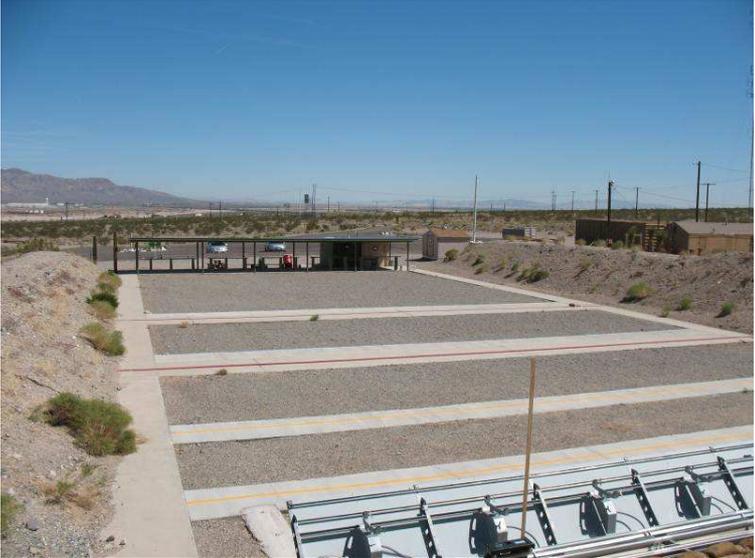
<b>Project:</b> MCLB Barstow		<b>Location:</b> Barstow, California	<b>Project No.</b> 06285037.0000
<b>Photo No.</b> 8	<b>Date:</b> 3-22-2012

<b>Description:</b> Pistol Range: View from top of berm towards firing positions during March 2012 site visit.

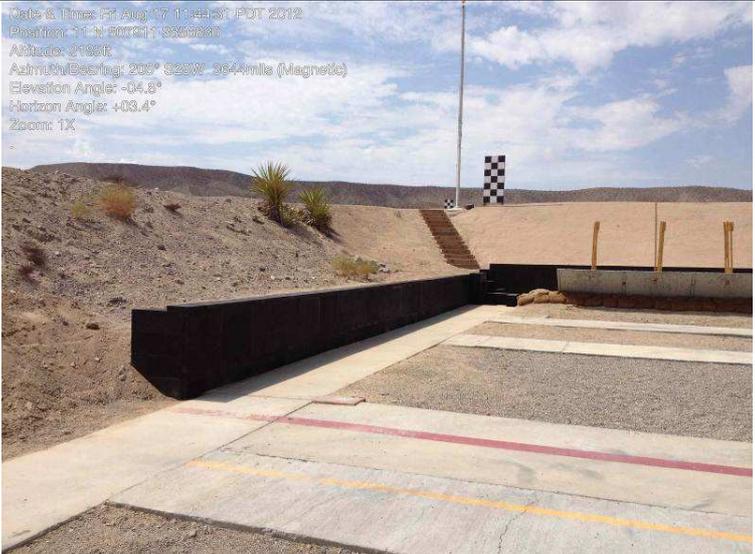
<b>Project:</b> MCLB Barstow		<b>Location:</b> Barstow, California	<b>Project No.</b> 06285037.0000
<b>Photo No.</b> 9	<b>Date:</b> August 2012

<b>Description:</b> Pistol Range: View downrange after lead mining and berm resurfacing action in August 2012.

<b>Maintenance</b>	The impact berms at all three ranges were reconstructed in August 2012. The existing soil was removed and sieved to remove lead shot. The final total lead weight for the projectiles recovered at MCLB Barstow is 12,110 lb. It is estimated approximately 50% of the material is from the Pistol Range, 35% from the Rifle Range, and 15% from the Shotgun Range (Sherer, pers comm). Prior to replacing the soil on the berms, erosion control matting (Envirogrid) was put in place. The soil was replaced on

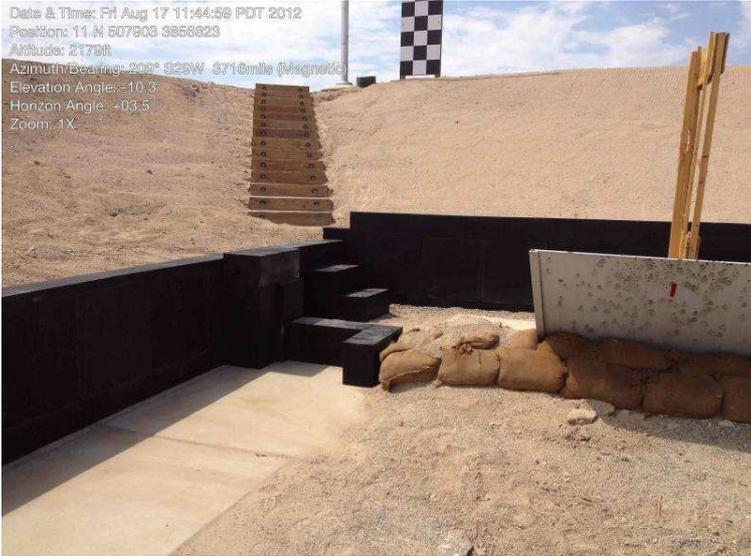
<p><b>Description:</b> Pistol Range after lead mining and berm reshaping. Note ballistic block retaining walls to reduce ricochet.</p>

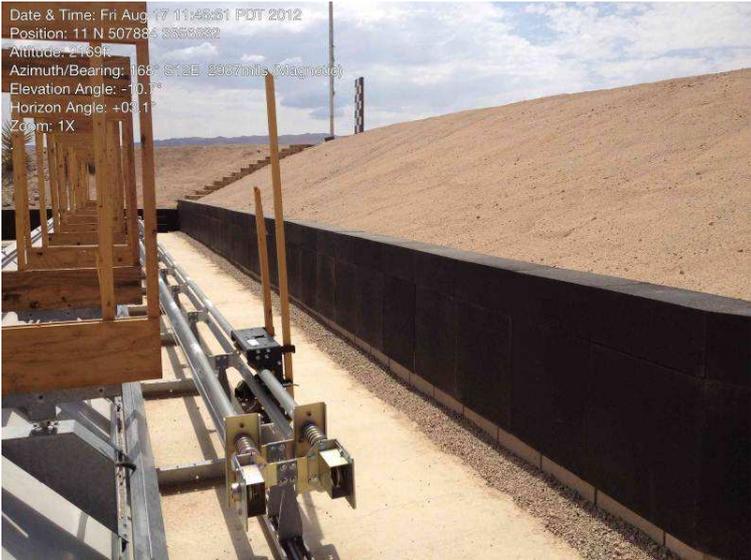
<p><b>Description:</b> Pistol Range after lead mining and berm reshaping. Ballistic block used at the berm retaining wall.</p>

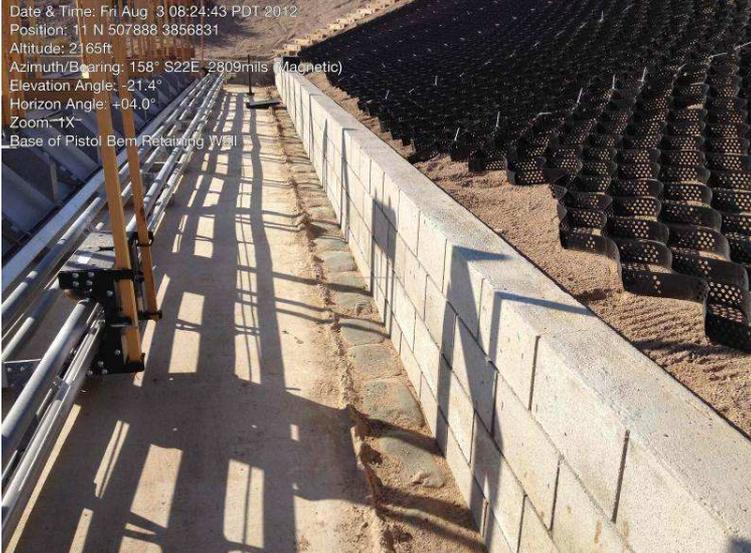
<p><b>Description:</b>                  Pistol Range: Base of retaining wall. Note the erosion matting (Envirogrid) used to minimize erosion.</p>

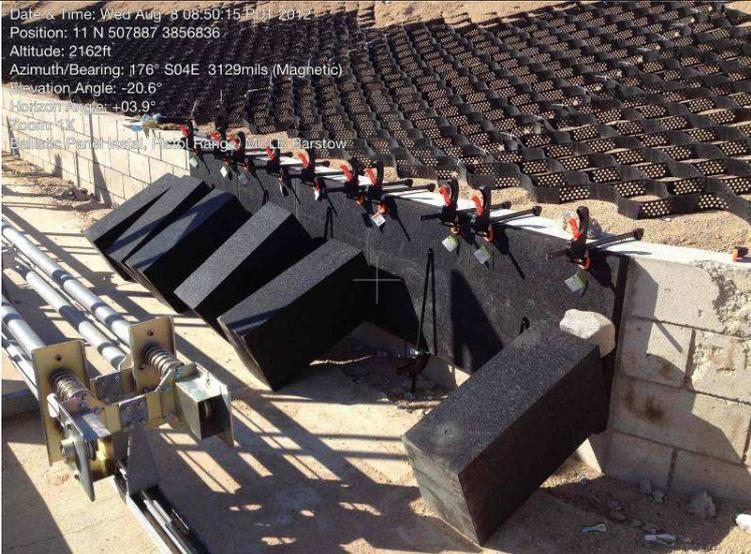
<p><b>Description:</b> First set of Ballistic Panel Clamed and Curing at Pistol Range</p>

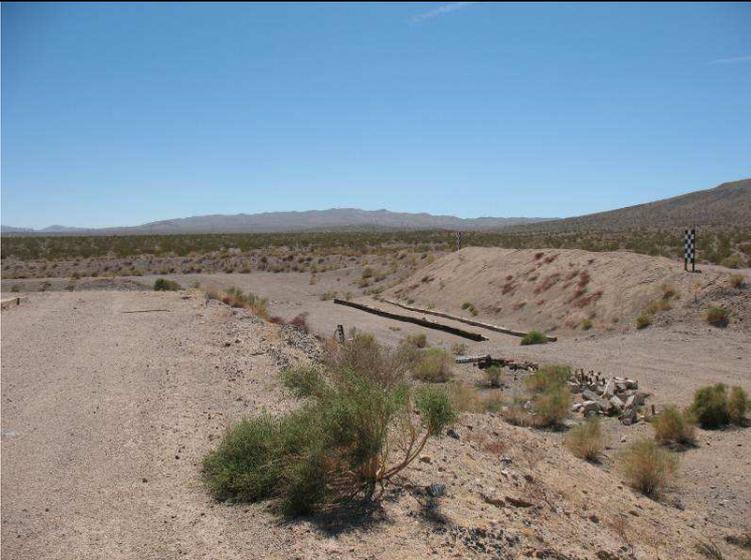
<b>Photo No.</b> 14	<b>Date:</b> 3-22-2012		
<b>Description:</b> Shotgun Range: view from on top of pistol range berm looking at shotgun range targets and berm during March 2012 site visit.

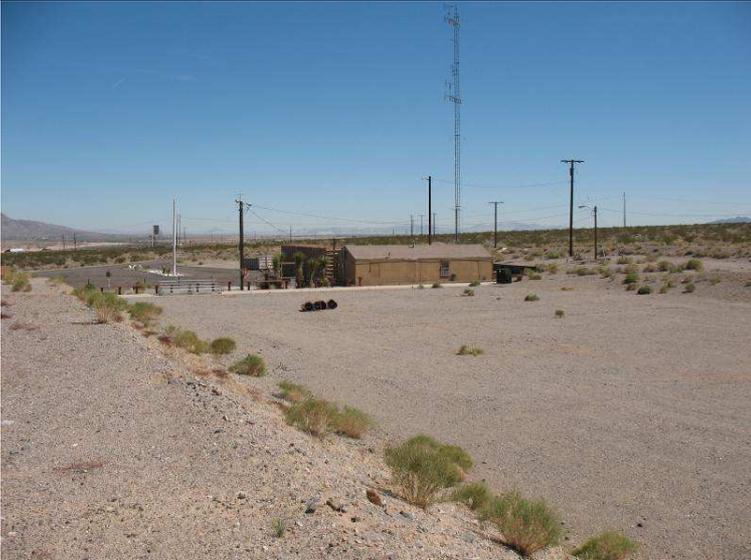
<b>Photo No.</b> 15	<b>Date:</b> 3-22-2012		
<b>Description:</b> Shotgun Range: view from Pistol Range berm looking uprange toward firing locations during March 2012 site visit.

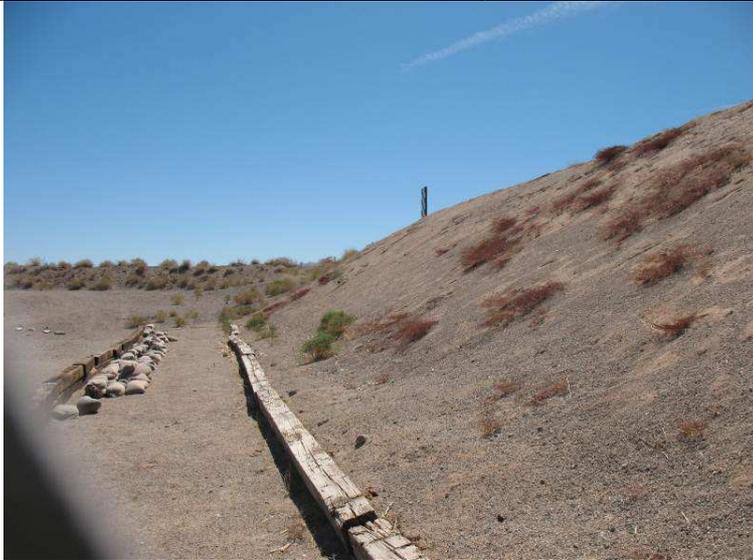
**Description:**  
Shotgun Range berm during March 2012 site visit.

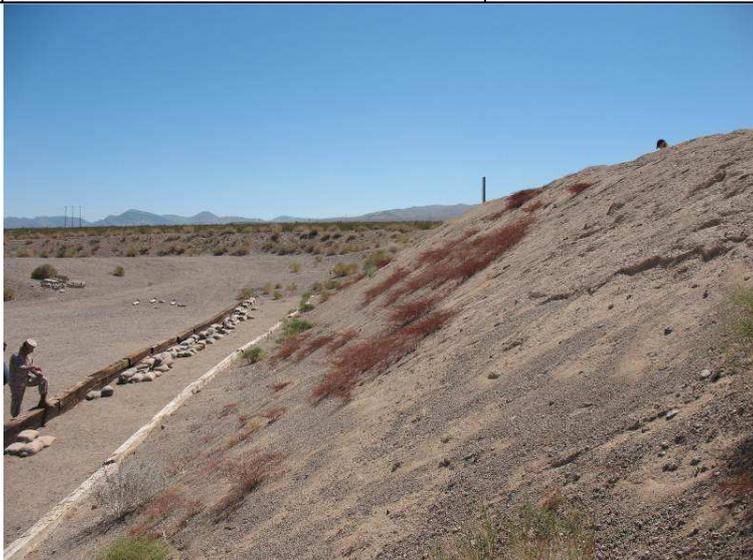
**Description:**  
Shotgun Range berm during March 2012 site visit.

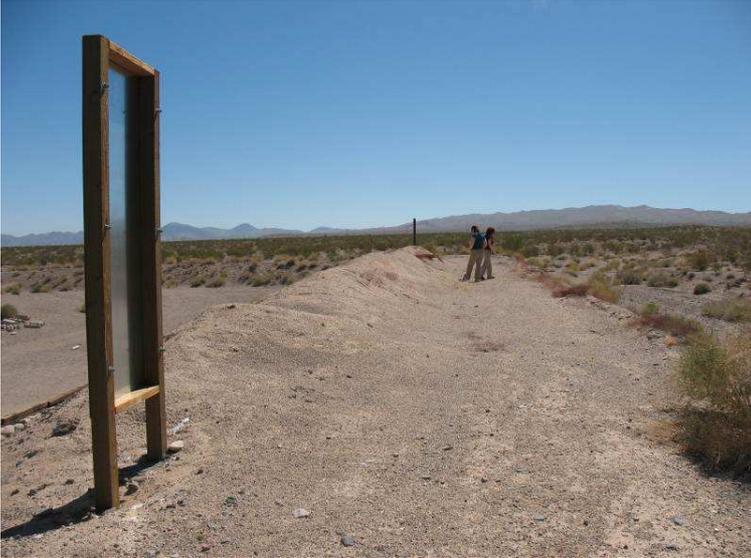
<b>Project:</b> MCLB Barstow		<b>Location:</b> Barstow, California	<b>Project No.</b> 06285037.0000
<b>Photo No.</b> 19	<b>Date:</b> 3-22-2012

<b>Description:</b> Shotgun Range: top of berm during March 2012 site visit. Note slight slope away from berm face.

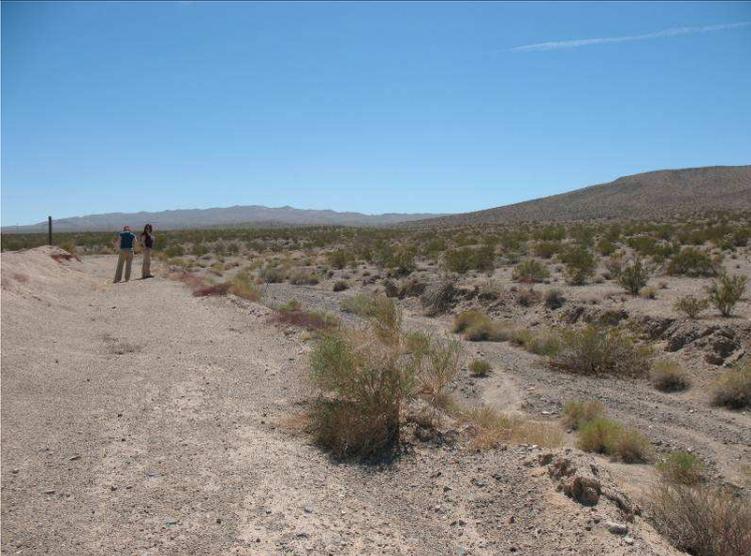
<b>Project:</b> MCLB Barstow		<b>Location:</b> Barstow, California	<b>Project No.</b> 06285037.0000
<b>Photo No.</b> 20	<b>Date:</b> 3-22-2012

<b>Description:</b> Shotgun Range: view of the back of the berm, notice terrace down to road bed.

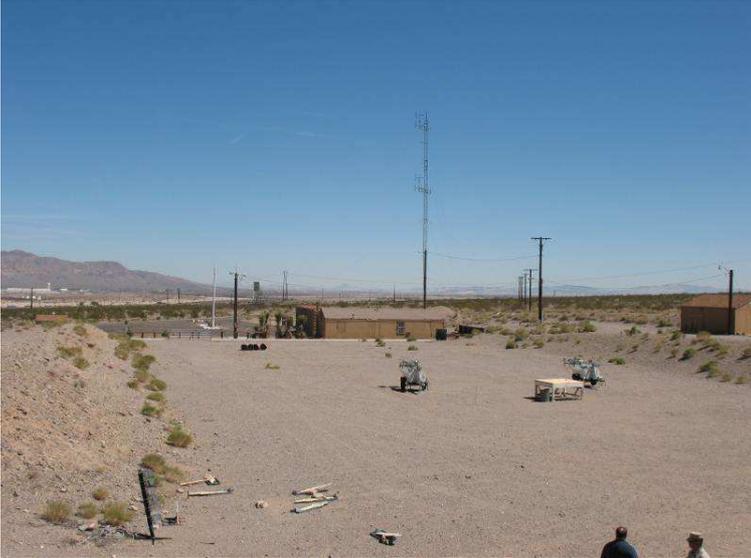
<b>Project:</b> MCLB Barstow		<b>Location:</b> Barstow, California	<b>Project No.</b> 06285037.0000
<b>Photo No.</b> 22	<b>Date:</b> 3-22-2012

<b>Description:</b> Shotgun Range: View from top of Shotgun Range berm towards firing points.

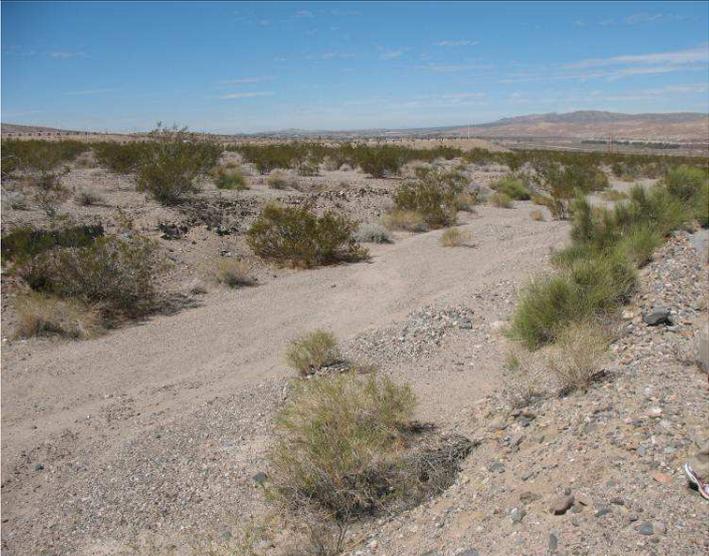
<b>Project:</b> MCLB Barstow		<b>Location:</b> Barstow, California	<b>Project No.</b> 06285037.0000
<b>Photo No.</b> 23	<b>Date:</b> 3-22-2012

<b>Description:</b> Behind Shotgun Range berm during March 2012 site visit.

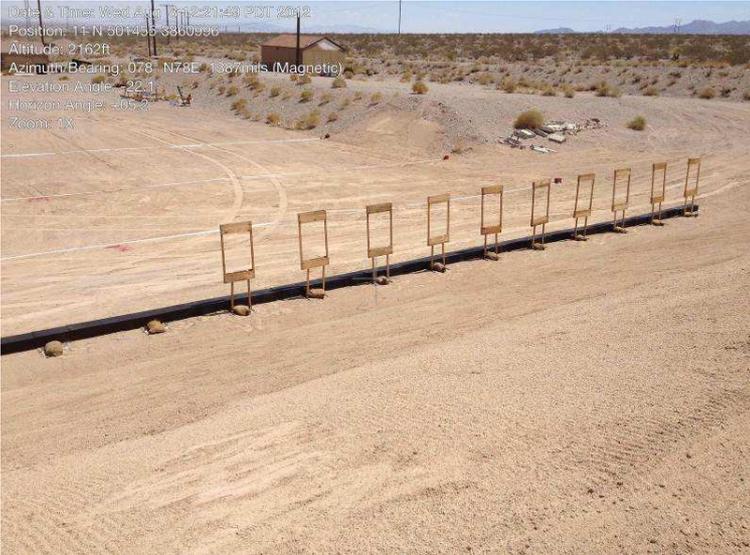
<p><b>Description:</b> Shotgun Range: View after berm mining and resurfacing in August 2012. View is from berm towards firing position of completed Shotgun Range as prepped for Shotgun Pistol Qualification.</p>

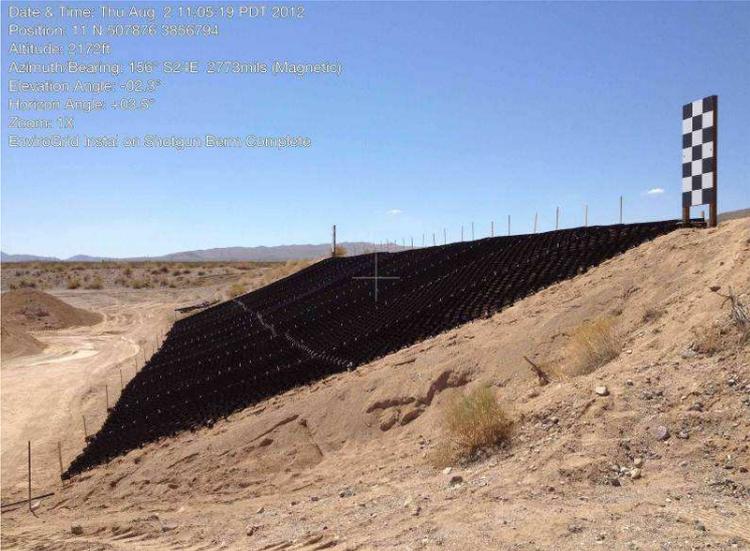
<p><b>Description:</b> Shotgun Range: Side view of EnviroGrid on Shotgun Berm during lead resurfacing in August 2012.</p>

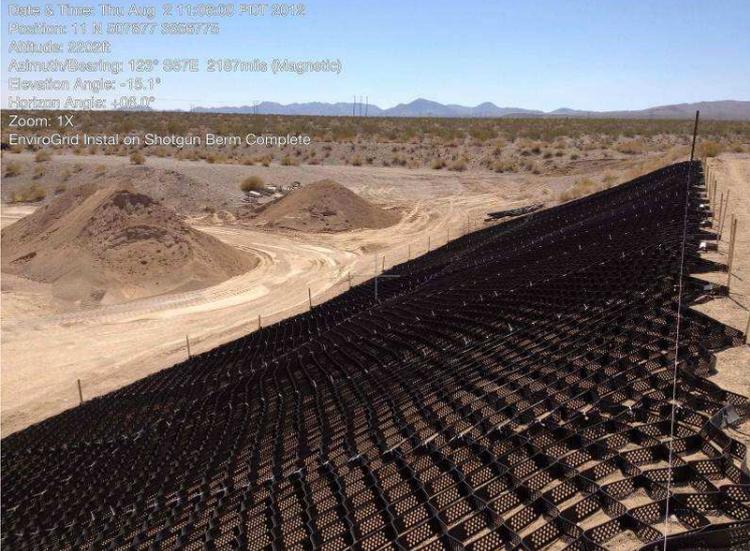
<b>Description:</b> Top view of EnviroGrid on Shotgun Berm during berm resurfacing in August 2012.

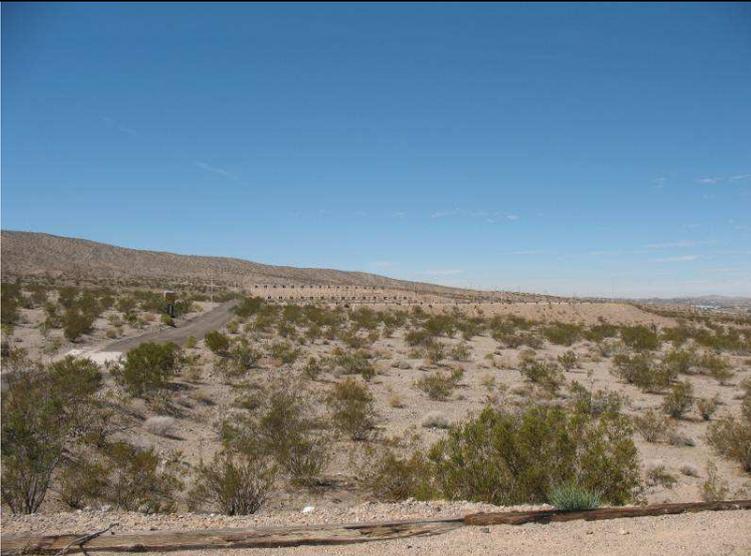
<b>Photographic Log</b>
<b>Project:</b> MCLB Barstow		<b>Location:</b> Barstow, California
		<b>Project No.</b> 06285037.0000
<b>Photo No.</b> 28	<b>Date:</b> 3-22-2012

<b>Description:</b> Rifle Range: View from 500 foot firing position towards targets during March 2012 site visit.

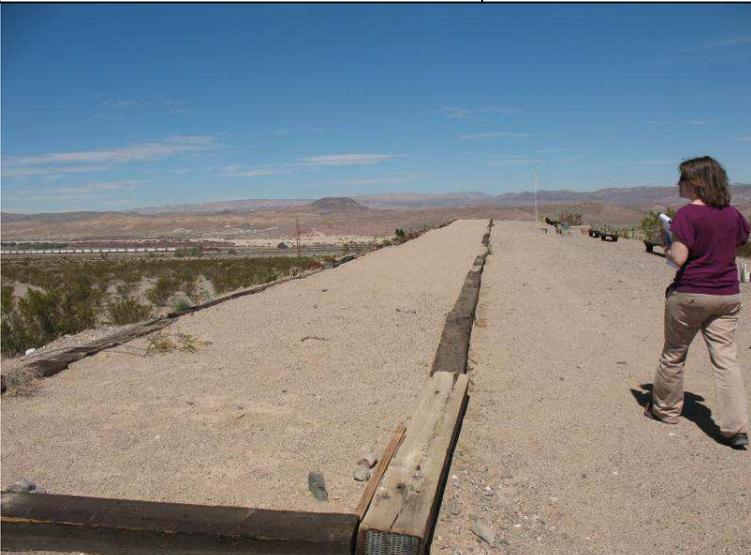
<b>Photographic Log</b>
<b>Project:</b> MCLB Barstow		<b>Location:</b> Barstow, California
		<b>Project No.</b> 06285037.0000
<b>Photo No.</b> 24	<b>Date:</b> 3-22-2012

<b>Description:</b> Rifle Range 500 foot firing position on March 2012 site visit.

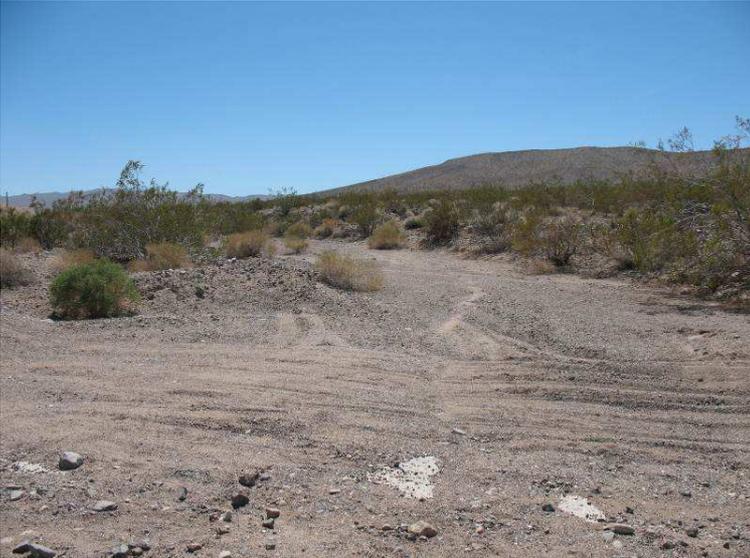
<b>Photographic Log</b>	
<b>Project:</b> MCLB Barstow		<b>Location:</b> Barstow, California	<b>Project No.</b> 06285037.0000
<b>Photo No.</b> 29	<b>Date:</b> 3-22-2012

<b>Description:</b> Rifle Range: Surface water drainage observed on Rifle Range during March 2012 site visit.
