Range Environmental Vulnerability Assessment  
5-Year Review  
Marine Corps Logistics Base Barstow  
May 2013

# **Range Environmental Vulnerability Assessment**

## **5-Year Review**

### **Marine Corps Logistics Base Barstow Barstow, California**

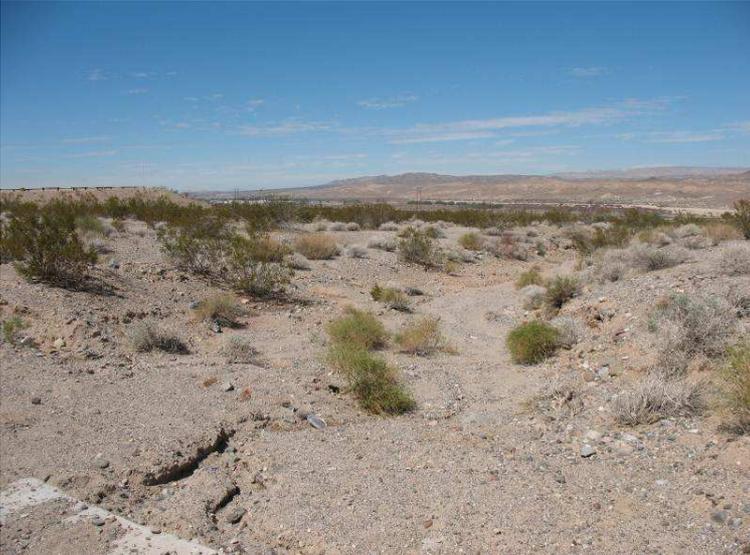
<b>Photographic Log</b>	
<b>Project:</b> MCLB Barstow		<b>Location:</b> Barstow, California	<b>Project No.</b> 06285037.0000
<b>Photo No.</b> 30	<b>Date:</b> 3-22-2012

<b>Description:</b> Rifle Range: Surface water drainage observed on Rifle Range during March 2012 site visit.

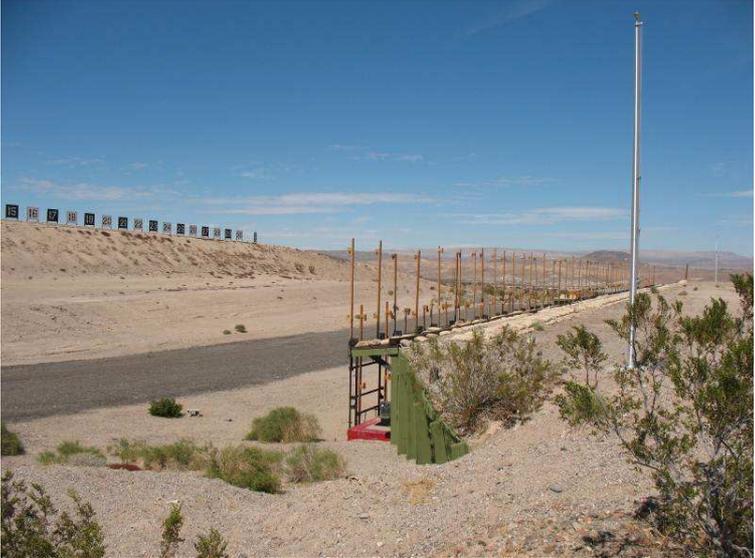
<b>Project:</b> MCLB Barstow		<b>Location:</b> Barstow, California	<b>Project No.</b> 06285037.0000
<b>Photo No.</b> 32	<b>Date:</b> 3-22-2012

<b>Description:</b> Rifle Range: Targets and impact berm observed on March 2012 site visit.

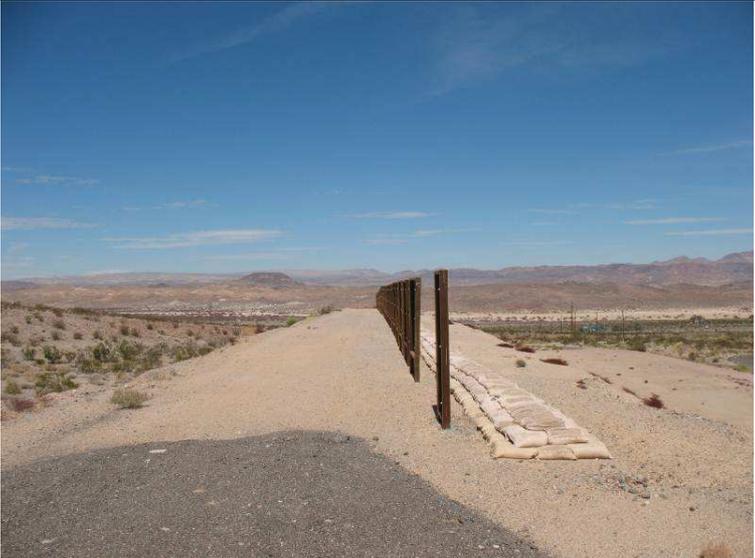
<b>Description:</b> Rifle Range: targets on March 2012 site visit.

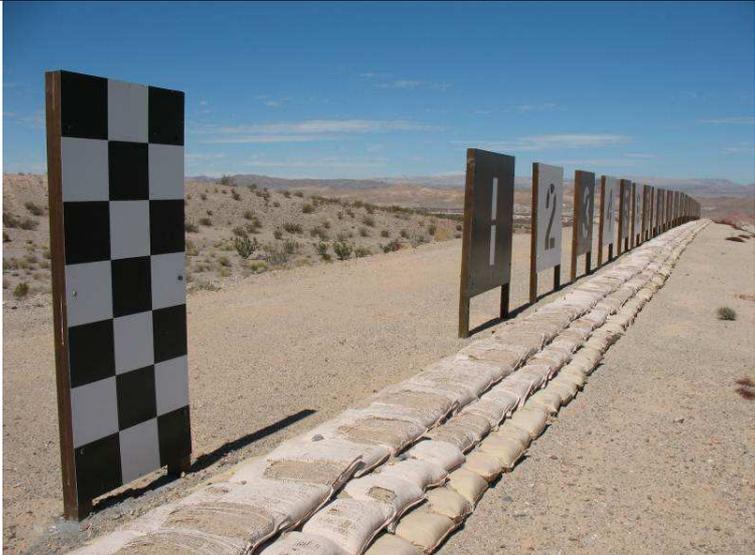
<b>Project:</b> MCLB Barstow		<b>Location:</b> Barstow, California	<b>Project No.</b> 06285037.0000
<b>Photo No.</b> 33	<b>Date:</b> 3-22-2012

<b>Description:</b> Rifle Range: Top of impact berm observed on March 2012 site visit.

<b>Engineered controls</b>	<p>Sandbags are placed across the top of the Rifle Range berm to help prevent erosion caused by high-energy runoff. The tops of all the berms are sloped slightly away from the berm face to minimize drainage flow across the impact area. Sandbags or wooden beams are present at the foot of the berms at the Pistol and Shotgun Ranges to help capture any erosion down the face of the berms. In addition, during berm reconstruction in August 2012 erosion control matting was installed on the face of the berms at all three ranges to limit soil erosion on the berm faces. The back sides of the Pistol and Shotgun ranges are terraced down to a flat road bed. Side berms at the Pistol and Shotgun Ranges divert</p>

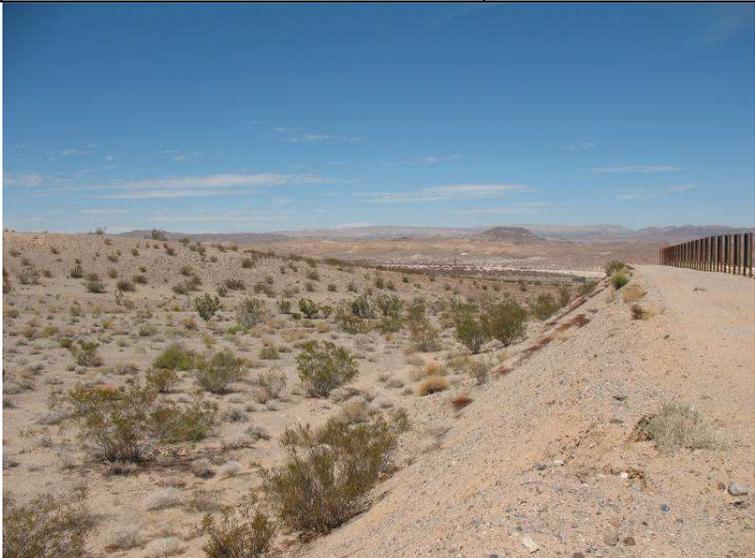
<b>ARCADIS MALCOLM PIRNIE</b> <i>Infrastructure · Water · Environment · Buildings</i>		<b>Photographic Log</b>	
<b>Project:</b> MCLB Barstow		<b>Location:</b> Barstow, California	<b>Project No.</b> 06285037.0000
<b>Photo No.</b> 34	<b>Date:</b> 3-22-2012

<b>Description:</b> Rifle Range: Backside of impact berm on March 2012 site visit.

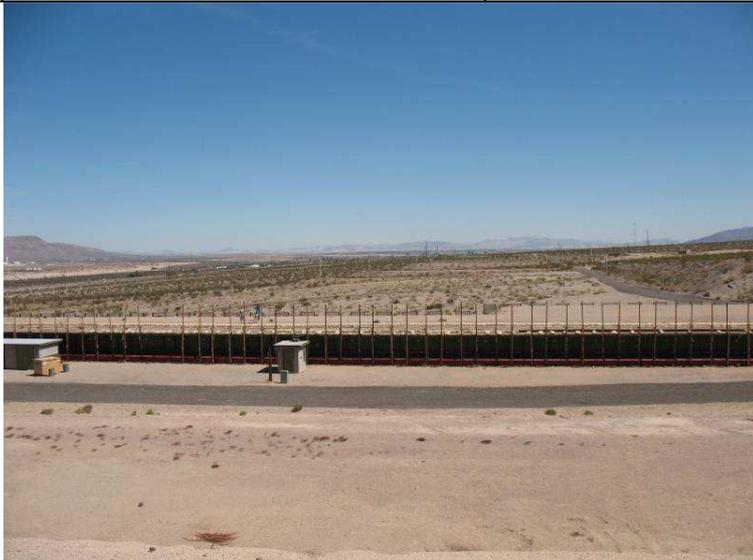
**Description:**  
Rifle Range View from impact berm towards firing positions on March 2012 site visit.

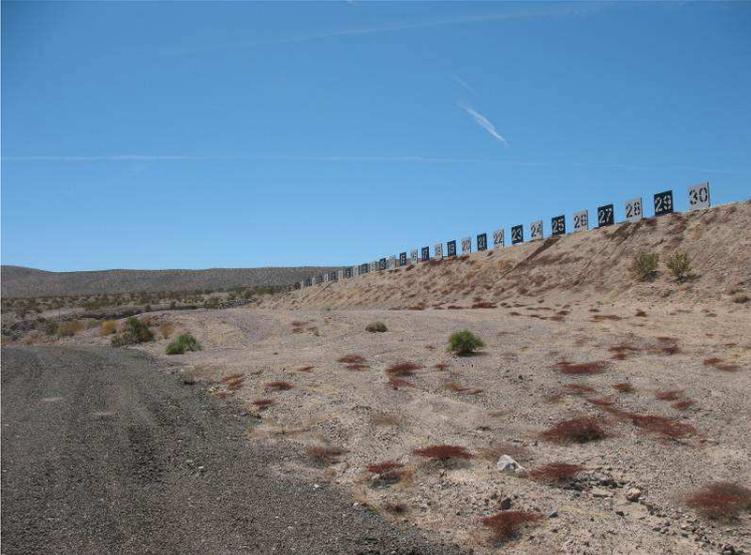
<b>Project:</b> MCLB Barstow		<b>Location:</b> Barstow, California	<b>Project No.</b> 06285037.0000
<b>Photo No.</b> 37	<b>Date:</b> 3-22-2012

<b>Description:</b> Rifle Range: Between target berm and impact berm on March 2012 site visit.

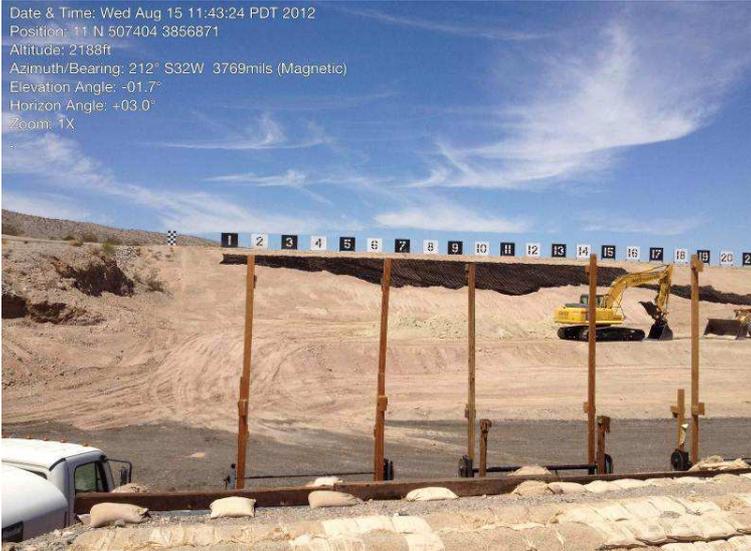
<b>Description:</b> Rifle Range: Berm being covered with EnviroGrid in August 2012.

<b>Maintenance</b>	The impact berms at all three ranges were reconstructed in August 2012. The existing soil was removed and sieved to remove lead shot. The final total lead weight for the projectiles recovered at MCLB Barstow is 12,110 lb. It is estimated approximately 50% of the material is from the Pistol Range, 35% from the Rifle Range, and 15% from the Shotgun Range (Sherer, pers comm). Prior to replacing the soil on the berms, erosion control matting (Envirogrid) was put in place. The soil was replaced on

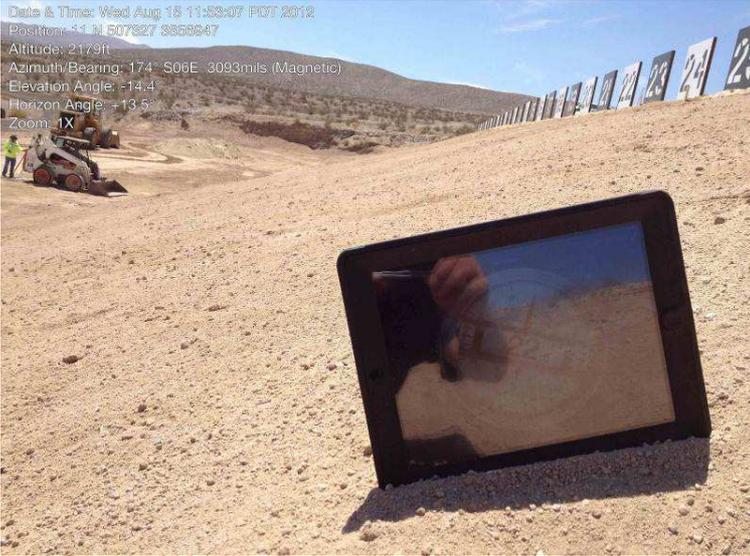
<b>Description:</b> Rifle Range: Confirming slope of Completed Rifle Berm in August 2012.

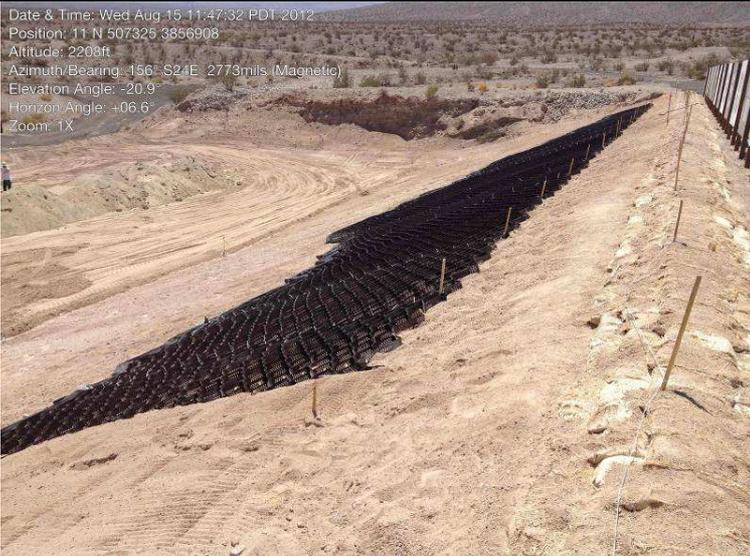
<b>Description:</b> Rifle Range: Top view of Envirogrid in place on Rifle Range impact berm in August 2012.
